65B Field Check

6/24/02

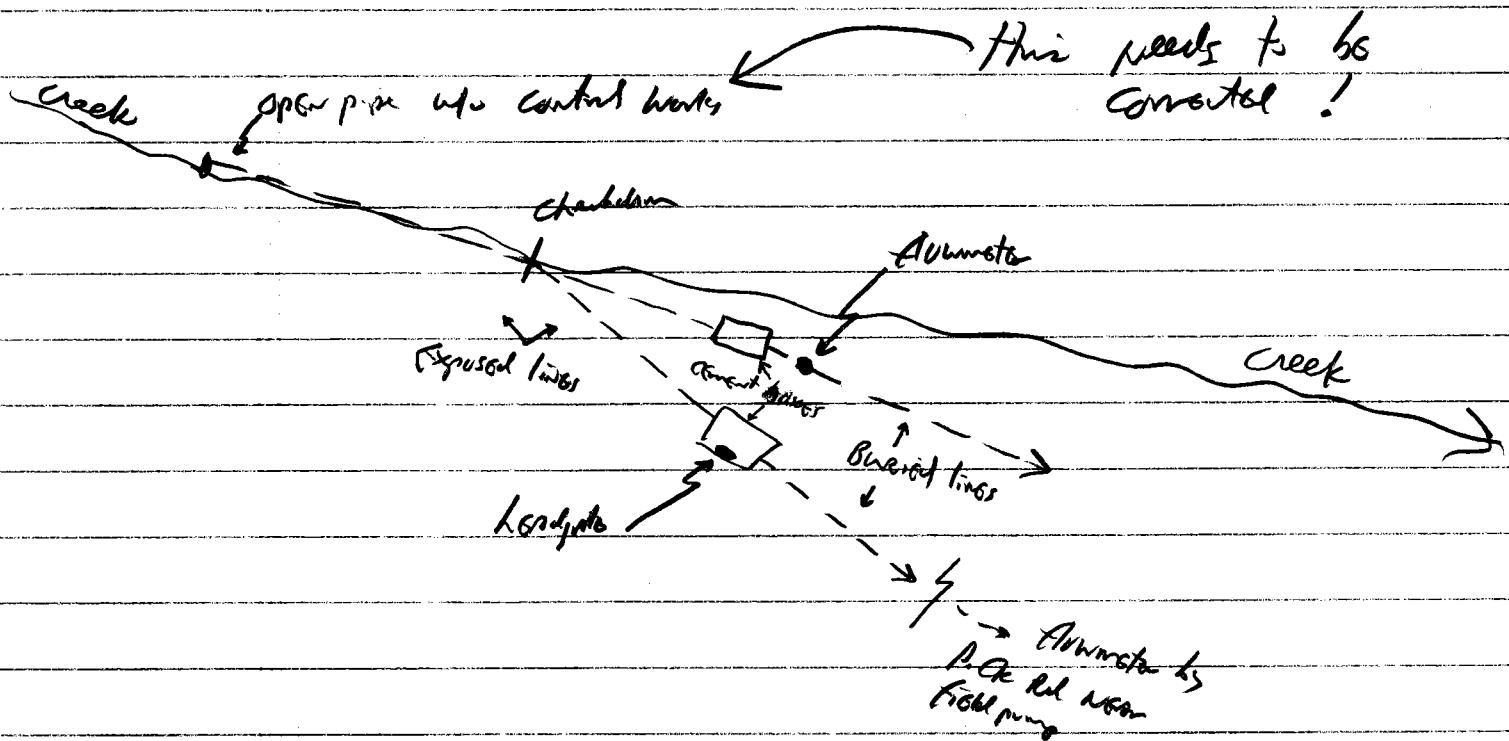
#4 - [#] G/7 plan site:

*following
needed* → ④ #6/7 (s other) pH .. Separated from common box, flumeter
new pH but no lockable controlable div. works.
Just added length of pipe to directly place in creek
just upstream from existing d.v. dam.

him will check meter & be sure ok. Water in use
but only minor amount.

I will contact HGF/Raw/Novel & unacceptable
look & controls & their plan.
